Waikawa Beach

Coastal Geomorphological Assessment and Management Options

Prepared for
Horizons Regional Council

Prepared by
Tonkin & Taylor Ltd

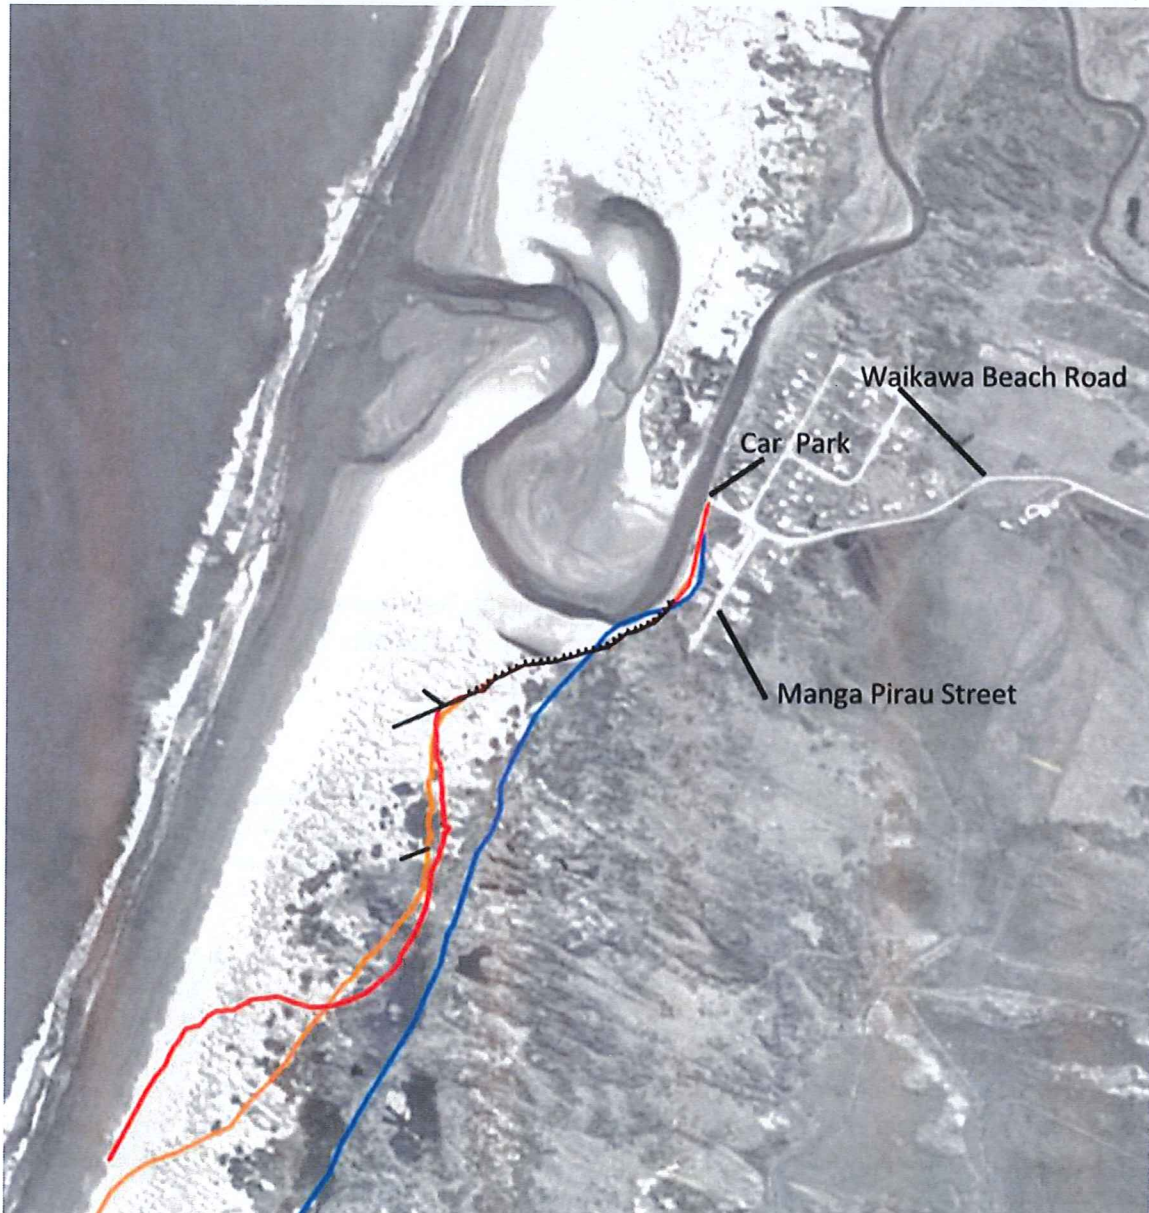
Figure 5: Typical post 1945-diversion response morphology on the 1968 aerial photo with the river meandering northward. The 1942 shoreline is marked purple, 1993 by orange and current 2018 by red. Structures are marked black as in Figure 4.

However, the 1957 to 1972 aerial photos show the channel beyond the diversion point meandering northward (for example see the 1957 aerial in Appendix E and the 1968 aerial photo in Figure 5) for some 500 to 700 m before turning seaward. Shepherd and Shepherd (1999) also note that beginning in the 1970s rocks were dumped along the bank immediately east of the car park as erosion was getting to close houses on Manga Pirau Street.

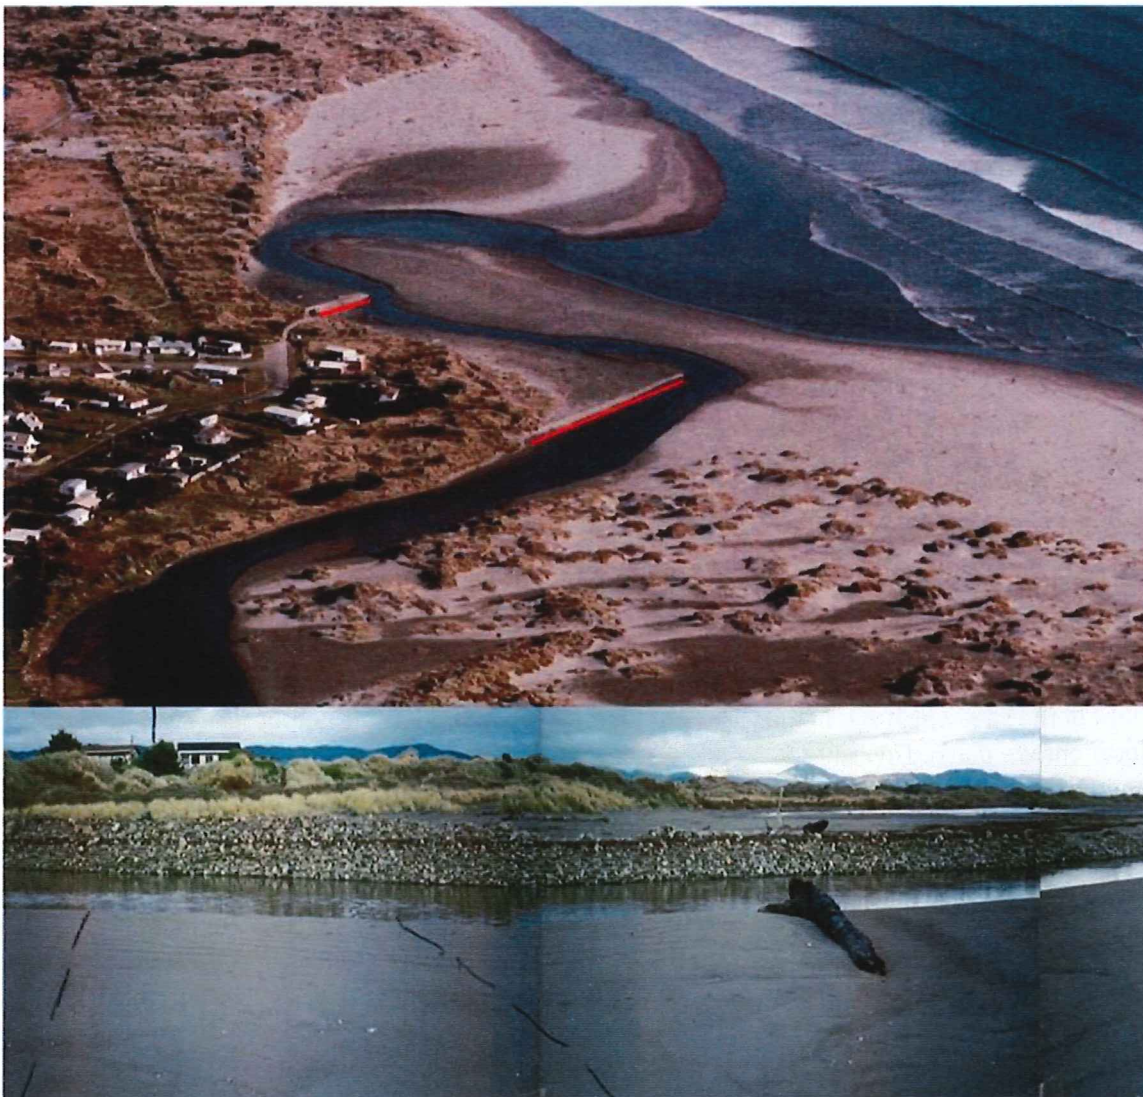
Figure 6: Upper photo (1996) shows the rock groynes (underlined red) that were constructed in 1991. Note the down-stream accretion behind each groyne. Lower photo shows the throat groyne in July 1994. Note the new dune development on accreting land on the far side of the groyne. (Source: kindly provided by Mr John Hewitson, Waikawa Beach).

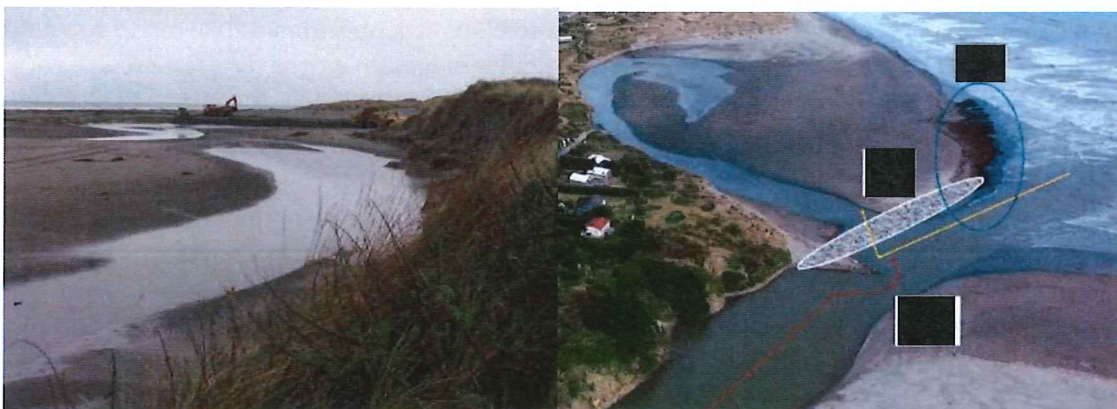
Figure 8: The most recent mouth cuts. Left photo taken on 10 July 2013 (source HRC), and right photo taken on 31 July 2018 (source HDC) shortly after the mouth cutting operation. Note in both cases the pre-diversion channel was against/close to the dune line at the back of the inlet. Note we were unable to source the original HDC photo so included the one above with various annotations unrelated to this study.

Mouth cuts were subsequently carried out in July 2013 (Figure 8 left) and July 2018 (Figure 8 right), each in response to the channel being in direct (or near) contact with the dune along the inlet bay. Note that the 2018 photo (Figure 8 right) shows the original groyne remnants still able to trap sediment on their downstream side.

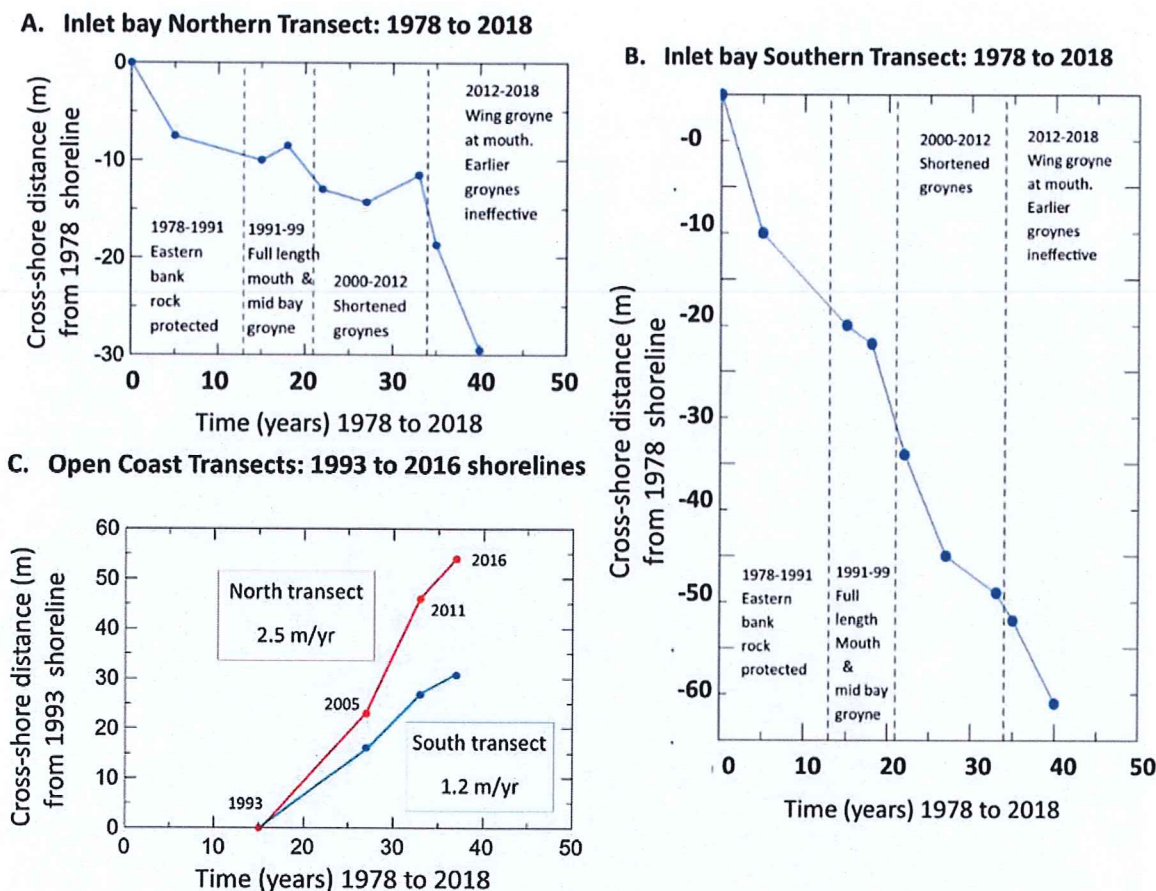
Figure 10: Shoreline change (based on vegetation-front) for the inlet transects (north Figure A and south Figure B) with locations marked in Figure 9. The period (1978 to 2018) covers the time since the inlet approach was fixed by rock lining of the southern bank in the 1970s. The periods of differing structural control are marked and annotated. Note graphs A and B have the same vertical scale to assist comparison. Figure C depicts shoreline-change on the open coast some 900 m north and south of the inlet (throat) over a somewhat shorter period (1993 to 2016) – this being required to avoid historical inlet behavioural response effects. All three graphs have the same horizontal (time) scale.

The vegetation edge, an indicator typically used to define an inlet bank or foredune toe, have been plotted for a northern and southern transect within the inlet bay – see Figure 9 for locations. The same grouping and time periods (spanning 1978 to 2018) were used for the channel analysis but a lesser number of data points are required for vegetation-based shoreline analysis as this parameter changes more slowly than channel location. In addition, shoreline analysis was carried out for the open coast with transects located approximately 900 m in either direction alongshore from the throat - far enough to avoid contamination by historical inlet dynamics. Historical inlet effects also resulted in use of a shortened time span (1993 to 2016) for the open coast data set.

The results suggest that the inlet bay (Figure 10A and B) shoreline is subject to systematic erosion with the southern transect having undergone about twice the amount of retreat as the northern transect shoreline (60 m c.f. 30 m) during the 40 year sampling period. In addition, the northern transect data indicates an increased erosion rate during the final period under the high-angle groyne, while the southern transect shows more uniform retreat throughout the sampling period.

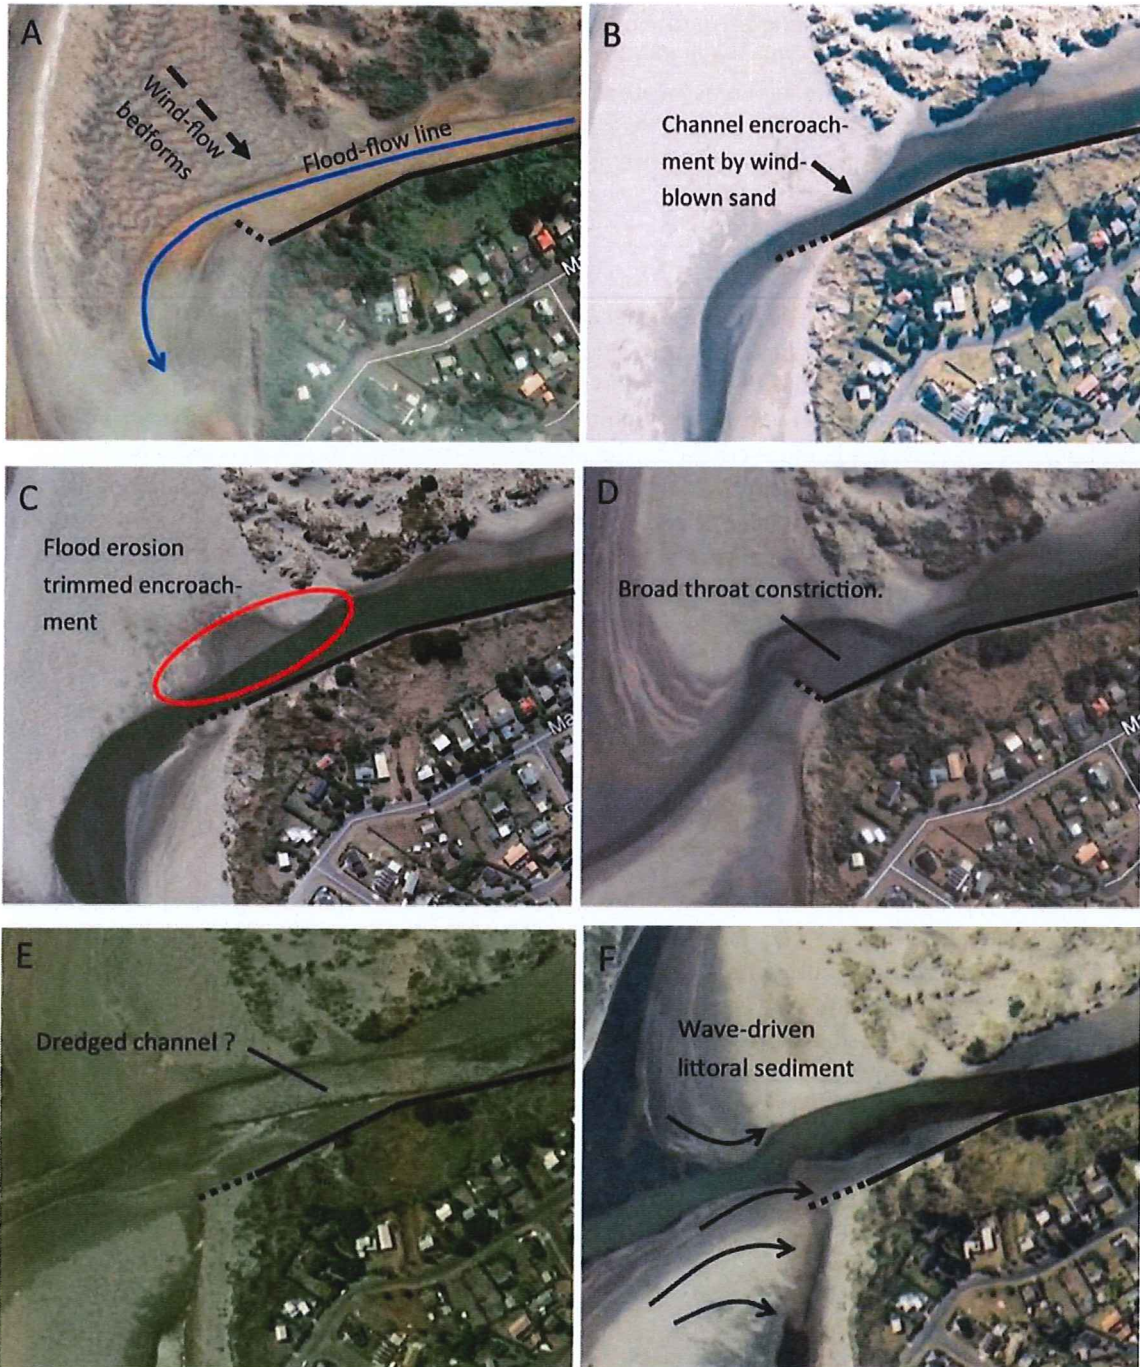
Figure 11: Configurations associated with throat constriction - see text for explanations. The black line defines the rock-lined southern embankment and the dashed black line marks the various entrance groyne. The bend mid-way along the southern embankment (black line) results in an approach channel misalignment with the original entrance groyne (dashed line in Figures B, C, E and F). Note the (apparently) dredged channel in E is more closely aligned with the upstream section of the marked southern embankment.

As noted in Section 3.2.6, there is a misalignment about midway along the approach channel which could drive the flow line toward the northern side of the throat. The misalignment appears to widen the throat channel and this could be expected to reduce flow concentration and thus jetting momentum under high flows which in turn would decrease scour potential across the fronting sandbank – a situation made more critical by the prograding (seaward trending) coast which increases the volume of this feature. Widening of the throat could also facilitate sedimentation within, and upstream of, the throat. The reduction in jetting and increase in sedimentation may also enable the channel to more easily meander toward the back of the inlet once past the groyne terminus. The current high-angle groyne may further exacerbate these situations as the flow is forced into an area of wind-blown sand accumulation (following paragraph), where it piles-up and has to redirect southward.

There is high potential for wind-blown sand to encroach upon the throat area from the northern beach as indicated by the bed forms in the vicinity of the dashed arrow in Figure 11A, and channel-margin bulge illustrated in Figure 11B. While it appears that flood-flows can clear the constriction in Figure 11C, significant shoaling within the throat can occur under more benign conditions (Figure 11D, and this could even necessitate dredging as appears to have occurred in Figure 11E (2005).

Littoral sand (i.e. beach sand) can reach the throat area under wave action along the channel margin during incoming tides (Figure 11F). However, this requires, the channel's sea-entry to be close to the throat rather than further southward along the inlet. It is noted that if the sea-entry is in the centre of the inlet, then littoral sediment can be transported landward at that location and potentially resupply the inlet bay. Furthermore, the recent lack of extreme southerly channel entry into the sea (indicated by the red envelope in Figure 9) prevents littoral sediment reaching this (southern) area; channel remnants (cut-off lakes) therefore persist and facilitate flood flow into this area as speculated earlier.

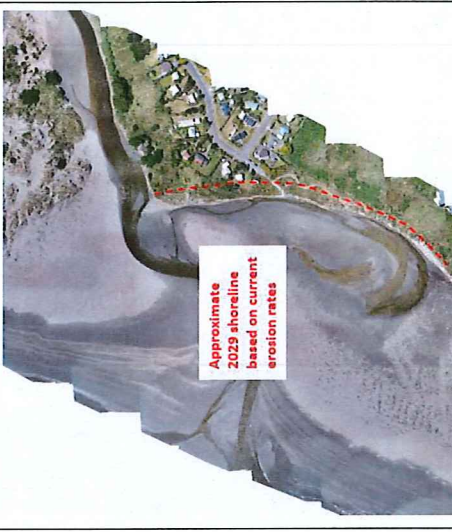
#	Description	Indicative Cost	Advantages	Disadvantages/Risks	Diagram
1	Do nothing	\$0	-No cost.	<ul style="list-style-type: none"> -Ongoing erosion along shoreline in front of likely. At present rates of 2.5m/yr (northern transect refer Figure 10) the shoreline would reach the 63 Manga-Pirau Street in approximately 10 years. Refer adjacent diagram showing the approximate shoreline in 10 years based on current erosion rates (note this is not a hazard line, a hazard assessment would be required to define a new setback line). -Resident opposition likely. -Residents likely to implement (non-engineered) hard protection without council involvement.

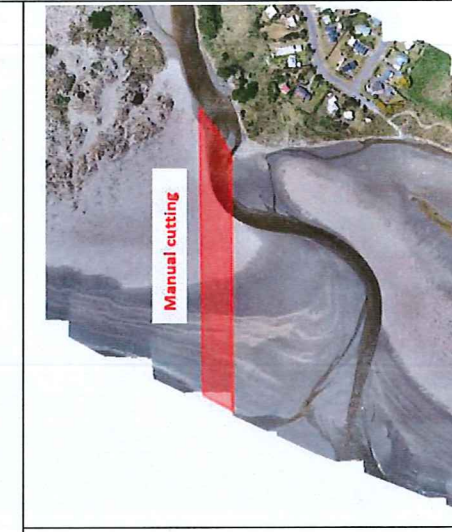
2	River training				
2a	Minimum - Manual cuttings. Implement a monitoring and trigger system and agreed mouth cutting method	\$40k capital \$10-20k annually subject to frequency of storms	<ul style="list-style-type: none"> -Low upfront capital cost. -Simple construction method -No imported materials required -No regrets solution (no rock placed on beach) 	<ul style="list-style-type: none"> -History shows only effective for short period until channel re-aligns southward. -Relatively frequent (biannual) cuttings likely required to prevent channel alignment returning to along the southern shoreline. -No additional protection to properties from large future storm surge/flood events. -Resource consent expires in 2020, will require renewing.

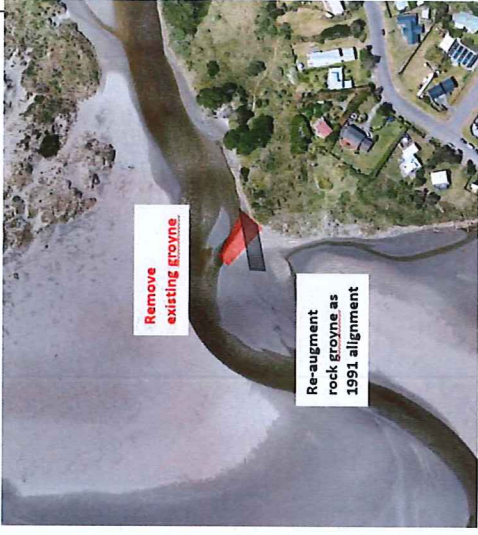
#	Description	Indicative Cost	Advantages	Disadvantages/Risks	Diagram
2b	<p>Moderate - Remove existing high angle rock groyne and augment the remaining 1991 alignment groyne (although to a shorter length than previous). Initial stream cutting likely required.</p>	<p>\$100k capital</p>	<ul style="list-style-type: none"> -Moderate upfront cost. -Low ongoing costs -Improve stream alignment and may improve natural flushing at throat. -Likely some accretion south of new groyne orientation. 	<ul style="list-style-type: none"> -May increase erosion pressure on existing rock groyne -No additional protection to properties from large future storm surge/flood events. -Short length of southerly protection, unlikely to encourage accretion at properties currently closest to shoreline (61, 63).

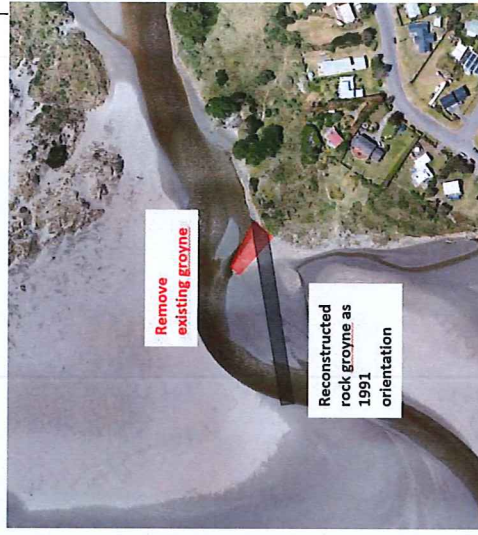
2c	<p>Comprehensive - Remove existing high angle rock groyne, augment and extend the existing rock groyne to similar length (90m) and orientation as 1991</p>	<p>\$580k capital</p>	<ul style="list-style-type: none"> -Inlet alignment forced further seaward at location of throat, possibly maintaining equilibrium with prograding open coast -Channel alignment less likely to retreat to southerly shoreline, reducing erosion risk to properties. -Decreased erosion rates evident historically with a groyne along this alignment. -Sand likely to build up in lee (south) of groyne providing some additional protection to properties. 	<ul style="list-style-type: none"> -High upfront cost due to moderate volumes of rock required to form structure (~5m³/li m) -Historical evidence shows unless construction is robust and structure is maintained, degradation and burial over time will reduce effectiveness. -No additional protection provided to shoreline from large future storm surge events.

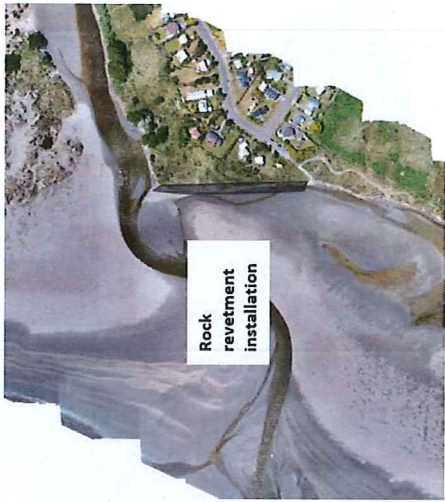
#	Description	Indicative Cost	Advantages	Disadvantages/Risks	Diagram
3c	Comprehensive - Installation of rock revetment along current shoreline to protect properties 55-63 Manga-Pirau Street from further erosion.	\$1,000k capital	<ul style="list-style-type: none"> -Provides greatest level of erosion protection to properties from both river flood flow and coastal storm (high wave/water level) events. -Minimal maintenance costs following initial capital expenditure. 	<ul style="list-style-type: none"> -Highest capital cost due to large volumes of rock required to armour shoreline -Potential for end effects as southern termination of revetment - wall may have to be extended -Likely to encourage river outlet to form a more permanent channel alignment along seaward edge of revetment. -Increased difficulty for vehicle beach access, will require engineered access location through revetment. -Effect on beach aesthetics.

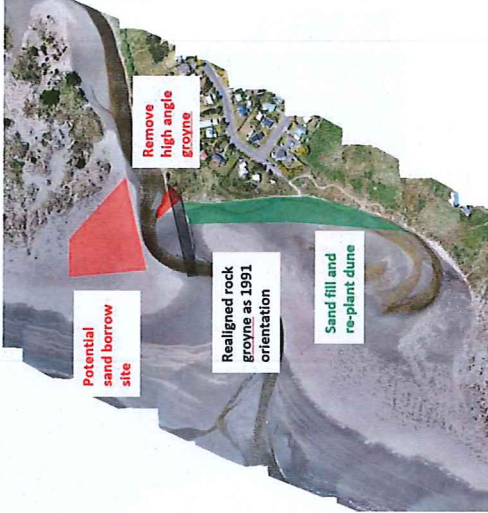
4	Combination of any of river training and bank protection options listed above	Varies subject to combination, refer associated costs.	As options 2 and 3 as well as: -Mitigates erosion risk from both river flows and coastal storm events.	As options 2 and 3 as well as: -High capital cost	<p>E.g.</p>
